The Newsletter of the Suffolk Historic Buildings Group

BEDFIELD HALL

A HOUSE WITH A LASTING HISTORIC DECORATIVE LEGACY

17th century ceilings and hearth revelations in a Suffolk house

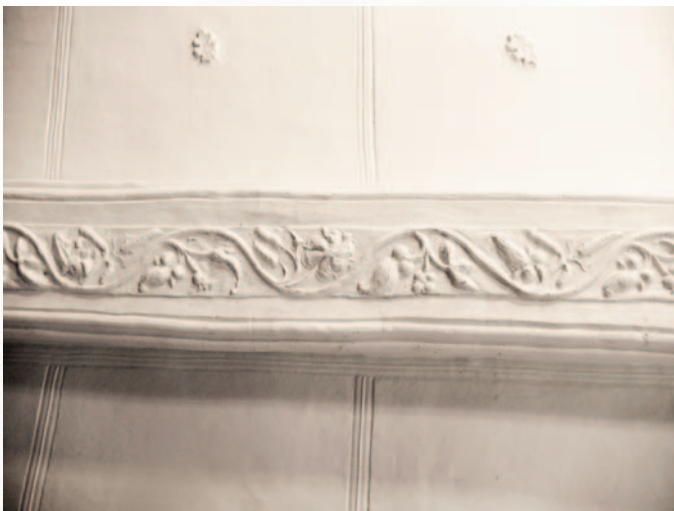
Fig. 1: Parlour chamber, 1630: detail of the unpainted mouldings on the underside of the plastered bridging beam.

The damaged ceiling of the parlour chamber was secured and repaired and the distemper was washed off with damp sponges. The appearance of the simple moulded features was immediately noticeably improved. A fresh mix of distemper, using size and chalk, was applied to the two main areas of ceiling on either side of the plaster-covered central bridging beam to give unity to the repaired sections. Any distemper applied over the decorative mouldings of the underside of this main supporting beam would unnecessarily dull the sharpness of these raised decorative features. Because there was no perceivable difference in colour between the fresh distemper paint and the original surface of the plaster, it was decided that this central feature should be left unpainted; the greater benefit being the retention of the sharpness of the moulded plasterwork (fig. 1).

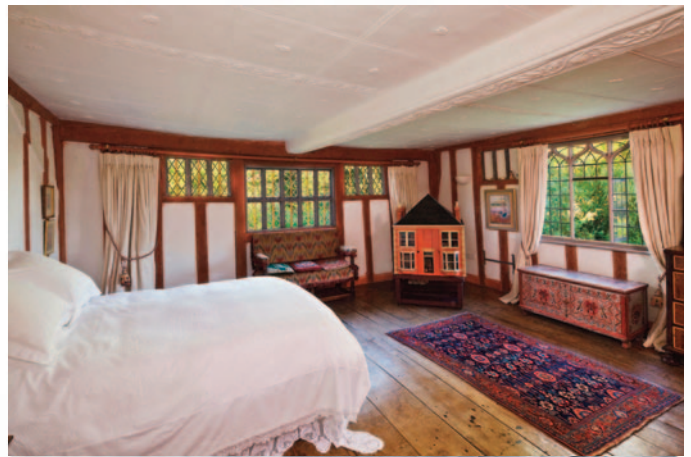
Fig. 2: Parlour chamber: the ceiling mouldings enhanced by clerestory windows.

The central strip of unpainted plasterwork is shown off to good effect by the two horizontal bands of clerestory windows along the two outer walls (fig. 2). Too high to be viewed out of, these bands of glass on the east and south walls illuminate and detail the ceiling and its mouldings from first light to mid afternoon.

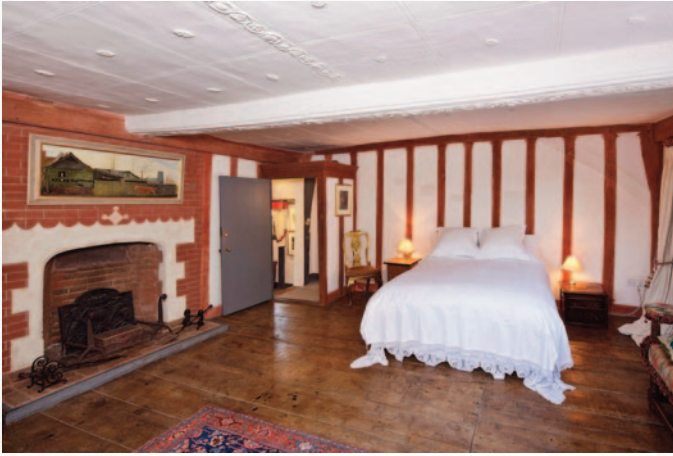
Fig. 3: Parlour chamber: the red-painted studs with a nod towards classical columns. Also the brick hearth enhanced by penciling against imitation 'stone' quoining and a corner porch added. This entry position was adapted from the original plan so as to give privacy between the rooms and cut down on draughts from the stairs outside.

This ceiling was planned to go with a scheme of red-painted studs (fig. 3). Whereas in all the other painted rooms (eight in all) the wall studs were painted with black pigment, to which chalk was added to create various shades of grey/black, here the red is used to distinguish the room as one of higher importance. The effect of a 'classical' inspired room was created by adding simple capitols and base mouldings above a painted base-board parallel to the floor. The date, 1630, is too early for this to have been the result of Inigo Jones's influence, but these 'columned' rooms seem to have taken their inspiration from the adapted

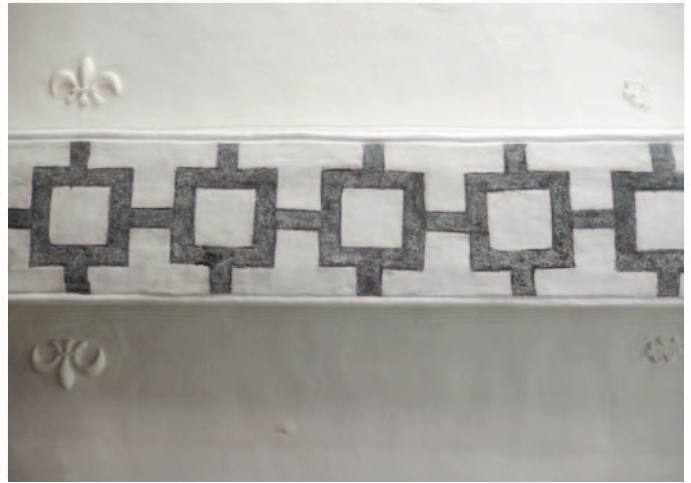
Fig. 5: The parlour, a section of the restored carbon-painted design; approximately 65% is original.

too heavy in that position, the plasterer had scored out a joined box pattern into the drying plaster; black size-based paint then followed on, filling in between the lines (fig. 5). Colour rarely plays any part in the enrichment on most vernacular ceilings and where it does occur it is usually there as a link to the walls. In this room the walls were panelled from the start.

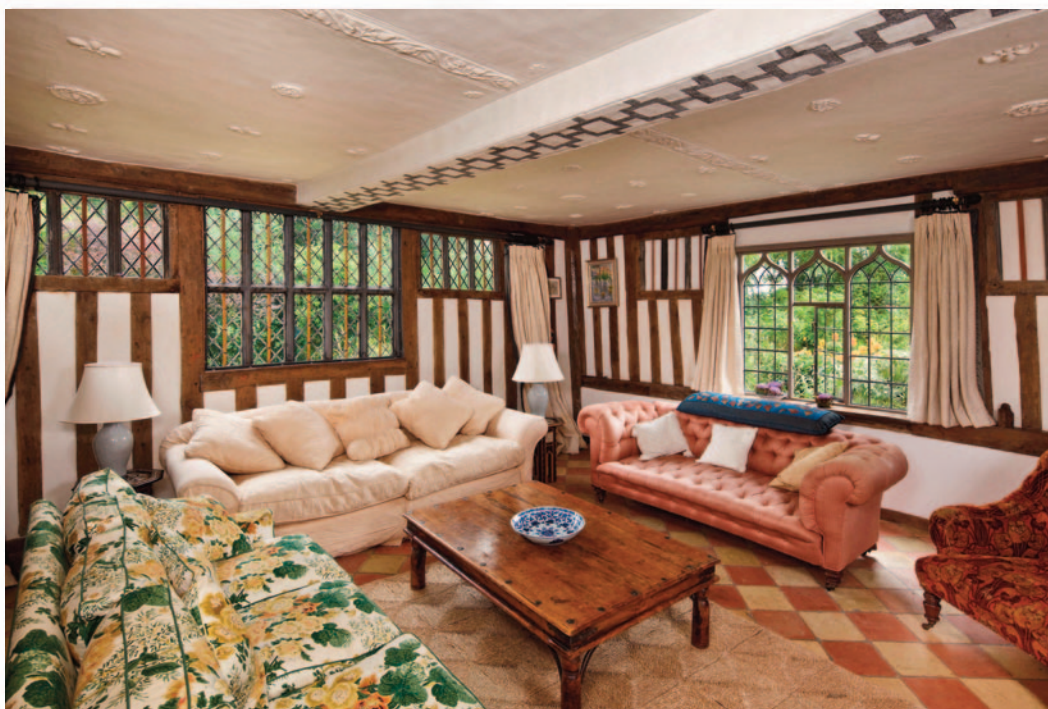
Fig. 4: The parlour, 1630. Note the closer proximity between the plastered bridging beam and the underside of window opening. Close stud work originally covered and 'wind sealed.'

A different solution was required in the parlour below. The bridging beam is joined into the outer mid rail, into which the mullions of the central window are directly secured, so the lower surface of plaster is much closer to, and level with, the top of the window (fig. 4). Perhaps because an embellished decorative pattern would look

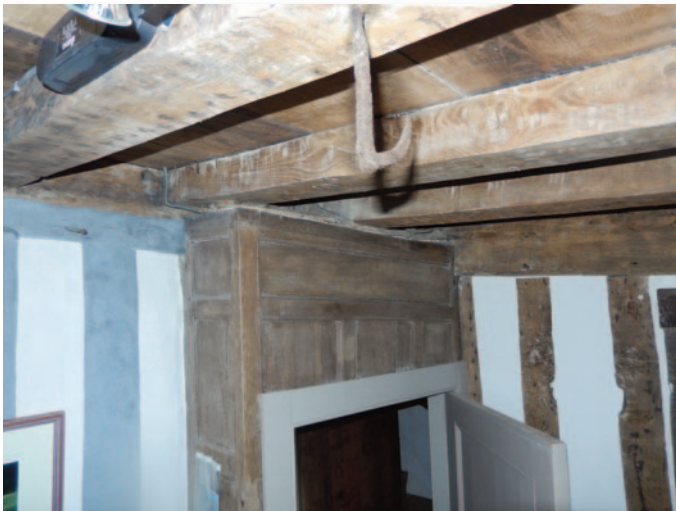
Fig. 6: Back parlour room. The 1630 paneled portal has a larger 19th c door than the original. The width of the upper cornice is indicated by a change in the timber colour. Originally this was set off by a plastered ceiling with painted studs on both sides. One of four old food hooks is shown, positioned over the 19th century stairs to a cellar. This was probably taken from the old kitchen ceiling.

The painted pattern on the bridging beam is one that can be found replicated in patterns used for panelling, so there could be a connection. However, some contemporary panelling which survives from the internal corner portal does not follow that design (fig. 6). This surviving section around the entrance faces into the room on the north side, so it may have been deliberately made different because this was a less important room.

The twelve food hooks were all taken out, and left deep holes where they had been hammered into each of three joists. There are four hooks of the correct date that were reused in the area beside and above a new cellar constructed in the first half of the 19th century at the back of the eastern wing (fig. 6). It seems likely these are from the kitchen, for a new alternative 19th-century

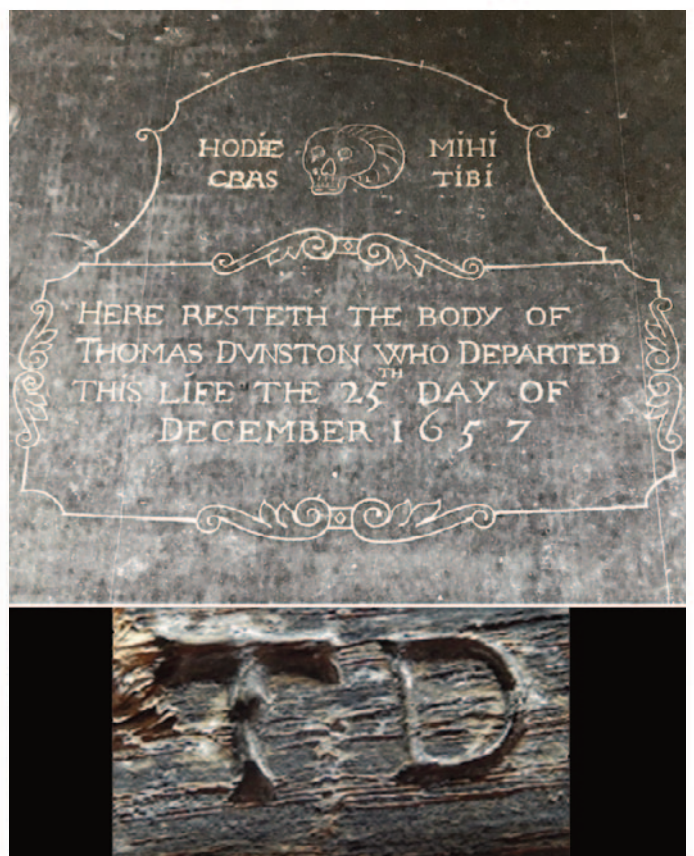
Fig. 13: St Nicholas church, Bedford. The inscribed 'Belgium black' ledger stone marking the grave of Thomas Dunston in 1658 and his personal brand stamp he applied to the new Kitchen hearth beam in 1620.

The east kitchen wing of the house was built from timber felled in 1619, so a 1620 build seems most likely. This is the year that Thomas Dunston bought the property and confirmed his ownership by branding his initials on the kitchen lintel (fig. 13). Here there are two ceilings which were painted. The more unusual of the two is the plaster ceiling of the new kitchen. It is painted with a dark colour which has not yet been analysed, but could be black pigment to mirror the colour of the wall studs. This is most unusual, for most ceilings were white-plastered and subsequently given fresh coats of distemper due to blackening by smoke escaping from the hearths. Here the paint is deliberate and one needs to ask why. The proof is because the central bridging beam reduced its girth through shrinkage in the decade that followed. Two strips of plaster were used to infill the gap between the two surfaces on either side of the reduced beam. (fig. 7). These were never painted.

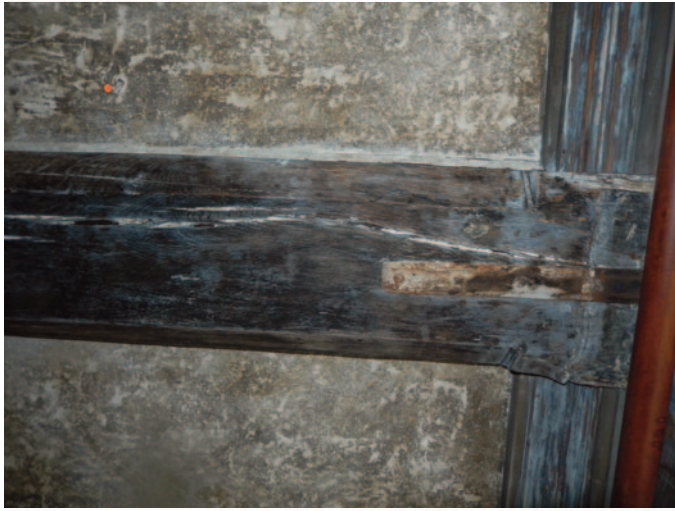
Fig. 7: Kitchen, 1620. A gap between the painted plaster and bridging beam was caused by the timber shrinkage of the beam. This has historic unpainted infill plaster, proving the painted plaster was intentional and original.

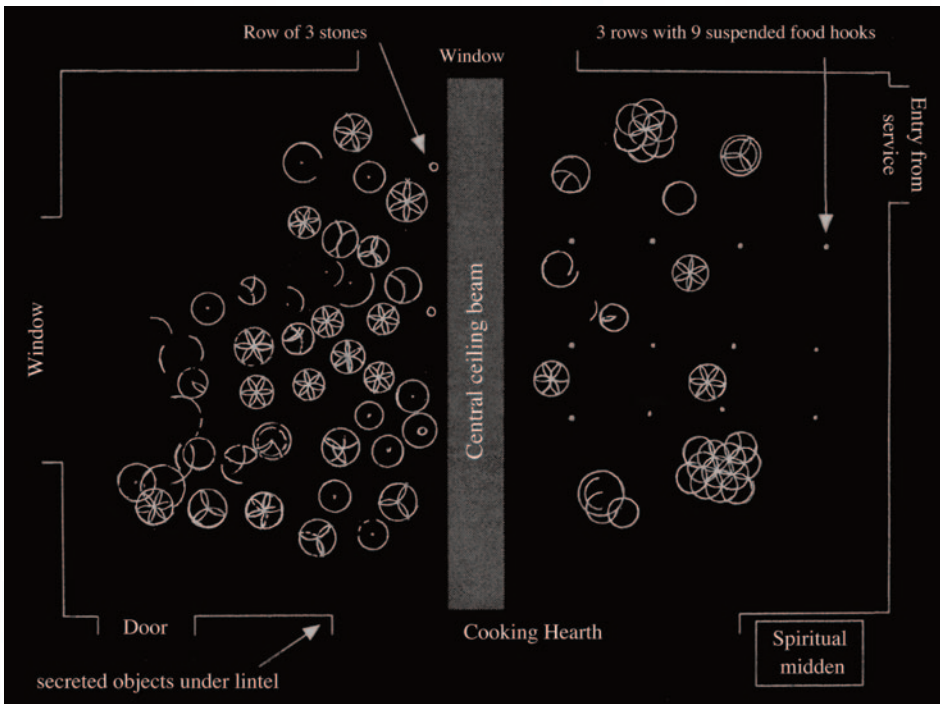
Fig. 8: Kitchen. The plan showing the distribution of compass-made symbols scribed through the dark-painted surface and the position of holes left where the hooks formerly were positioned.

The reason for this unique dark ceiling appears to be as a foil for some specific placed geometric patterns distributed around 12 hooks used to suspend foodstuffs for drying and preserving (fig. 8). A similar practice was witnessed in 1980s in the mountainous region of southern Spain, where air-cured hams were a speciality and suspended with herbs. In the half of the room beside the corner entrance where a preparation table may have stood, individual circles and arcs are positioned

between the hooks, with two larger clusters marking the outer zone. In the other half of the room, with evidence for former food-storing shelves on the walls, the circular patterns are more varied.

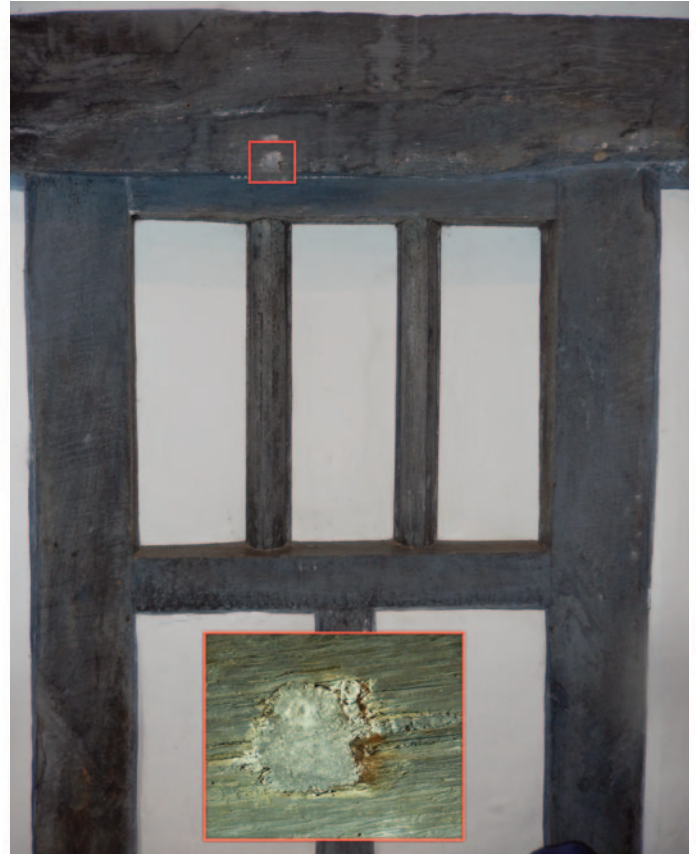
Fig. 11: The 1630 former 'room between the doors' has a plastered-covered peg hole that retains the original grey colour. The studs are painted to match, but the original oil-bound black pigment on the mullions was to give the illusion of dark stone.

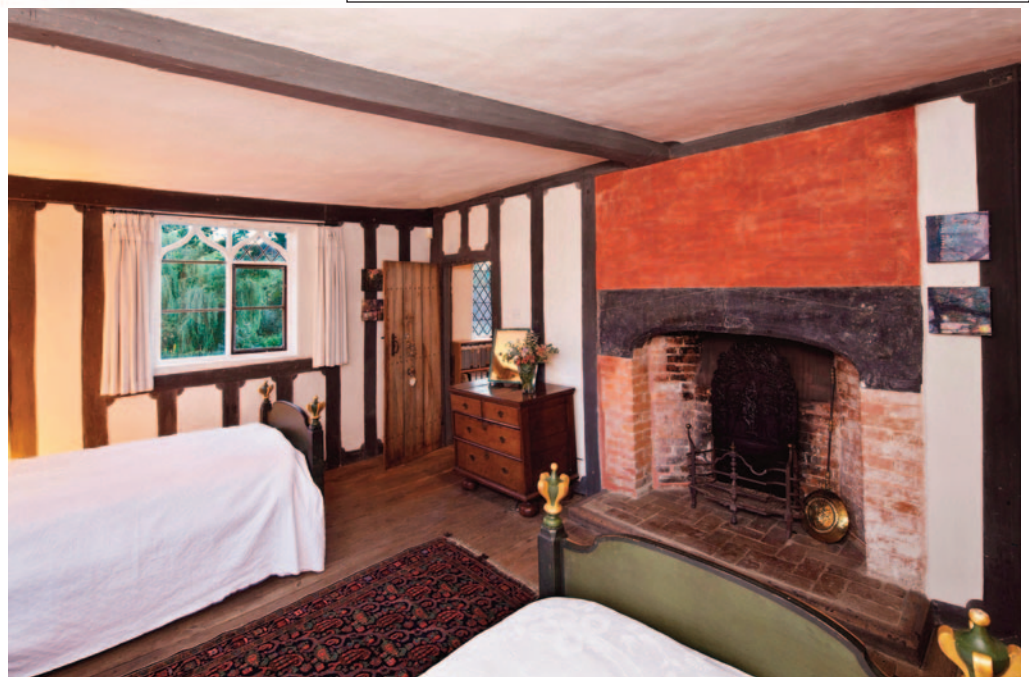
Fig. 10: Kitchen chamber 1620. The painted studs with additions make rudimentary columns, adjacent to the painted hearth. Faux 'Belgium black' on the arch imitates marble and the red paint above over the squared-up plaster imitates terracotta tiles.

The painted studs replicate the colour used in the room below, but with two additions. These are the extra quarter circles added top and bottom, which echo the treatment in the parlour, painted 10 years later, and create the illusion of a columned room (fig. 10). The other detailing is the additional quarter circles painted on the ceiling at either end of the painted bridging beam and in the corners. Having stated that paint on ceilings was not common, this is the third ceiling in one building that include some painted additions, albeit simple in concept.

Another reason for the recreation of the scheme is centered around the room's principal feature, the painted hearth (fig. 10). The wall and hearth decoration was made in the early 17th century, when there was less desire to use the more elaborate imitation textile designs of the previous century. Here the upper section has been squared

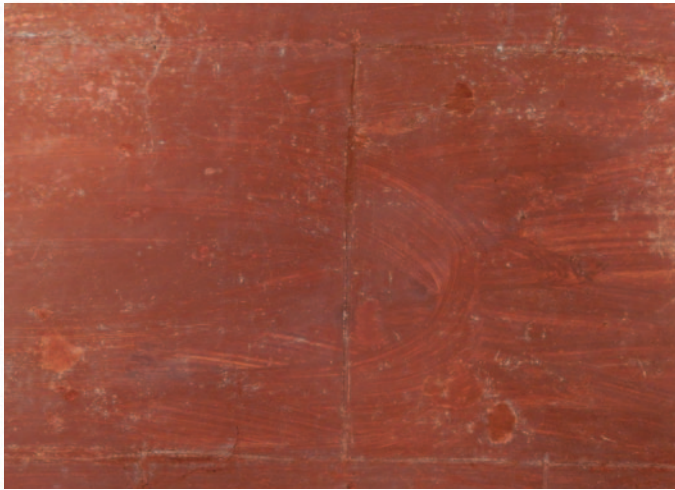
Fig. 12: Kitchen chamber. Wide brush marks shows the speed the painter needed to work on barely dried plaster.

up with scribing lines to imitate tiles, and the painter has worked very quickly across the drying plaster with red pigment to create the illusion of terracotta tiles (fig. 12).

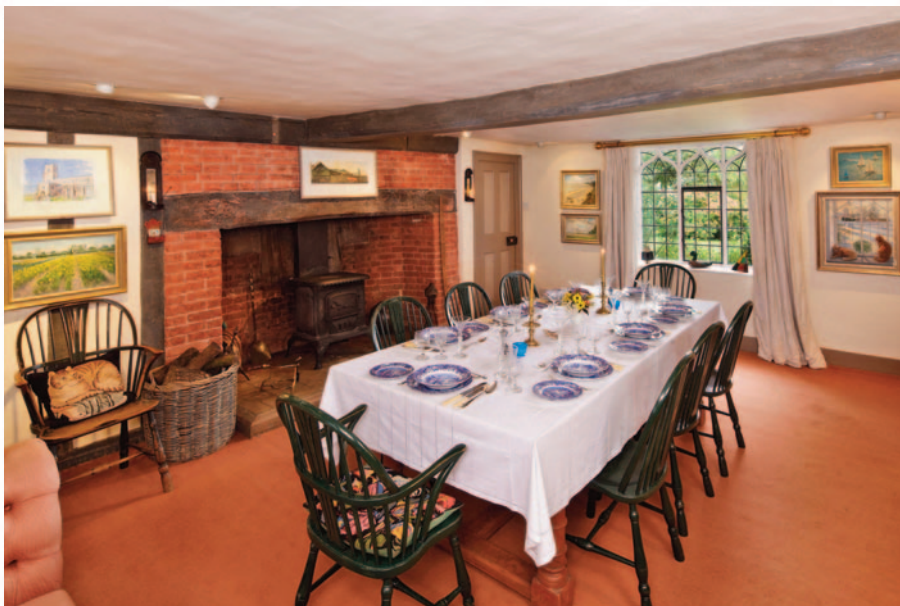
Fig. 15: The Hall of 1422. The ruddled and penciled hearth of 1630 replaced another 25 years older to change the circulation area on the North side of the chimney. An exposed chamfer-joisted ceiling was in place during the 1570s and was plastered over during the 1630 improvements.

As expected, the brickwork shows the same residual painted evidence as elsewhere in the house. There are five hearths in this wing, and four of them have ruddled brickwork, but without any pencil lines. One of the five hearths was found too mutilated so it was covered over in 1982. Three of the four 1630 painted hearths in the eastern parlour wing and Hall area are penciled (fig. 15); this is not a specific age-related fashion but the choice of the builder. It is just that some builders painted the pencil lines and others did not.
