# Eavesdropper

The Newsletter of the Suffolk Historic Buildings Group

No. 37 Spring 2008

## GETTING TO THE CORE : RE-ANALYSING AN HISTORIC BUILDING AFTER SUCCESSFUL DENDROCHRONOLOGY

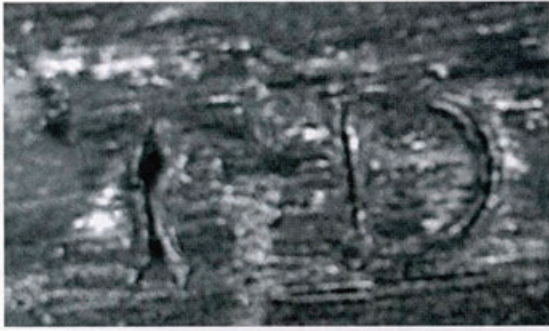
**Fig. 3: Painted plaster ceiling with inscribed circular patterns to protect food and activities within the kitchen. The three rows of holes were herbs and food were suspended on hooks. On the opposite side of the main ceiling beam is a row of three large holes containing stones pushed into the wet plaster and covered over, probably representing the Trinity symbol of protection. Many of the circular patterns are deliberately unfinished.**

there is the extraordinary ceiling that Thomas Dunston commissioned to ward off malevolent spirits and protect the food suspended from one half of the plaster ceiling on three rows of hooks (Fig. 3).

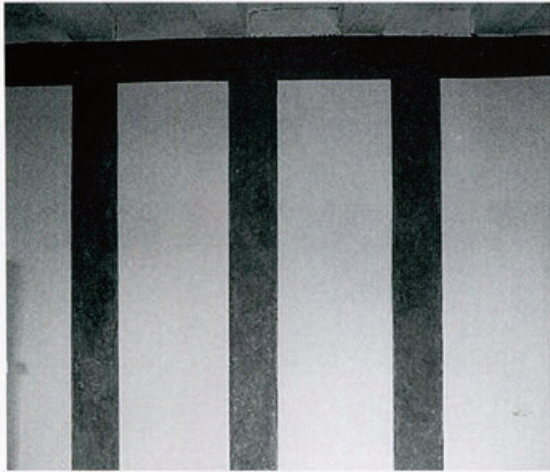
**Fig. 8: North walls of Parlour and Parlour Chambers - the dotted lines represent the original positions of timbers. The scribed numbers representing Numbers 5, 7, and 9 are missing from the wall. No. 5, the left hand jamb of the central door frame together with the head were used to construct the door frame in 1629 leading into the room in the South West corner of the Parlour**

Now the new corridor was made on the other side of the stack this central door was blocked and a Portal constructed in the North West corner of the Parlour Chamber. Exactly the same changes are mirrored in the rooms below (Fig.8). The Portal would cut down the draughts from the new stair to the attic and give greater privacy between the two rooms on each floor. The Parlour and Parlour Chamber north partition walls both contain some carpentry details that enforce the theory that changes were made as the frame was being raised. Most of the studs are in their original mortices and pegged in position in the upper room. By cutting out two studs and a brace on the left side an opening was made to accommodate the corner Portal. The head of the central door entrance was removed and another stud was inserted vertically to fill the gap. This is morticed top and bottom and pegged in place, which could only have been done during assembly (Fig. 8).

The corresponding studs to the right of the doorway immediately below are all in their allotted places but those of the left side are not. In fact the jambs for the central door have both been shifted and the one that should have been on the right side is now three studs to the left. The position of the moved studs does not relate to the pegged mortices of the original positions and the spaces between them are quite different to any others in the Parlour. Note presence of carpenter's marks that helps to decide the original position of the studs in the lower wall. The stud irregularity did not ultimately matter as these walls were panelled. Part of the matching panelling survives in the next room as the other half of the portal.

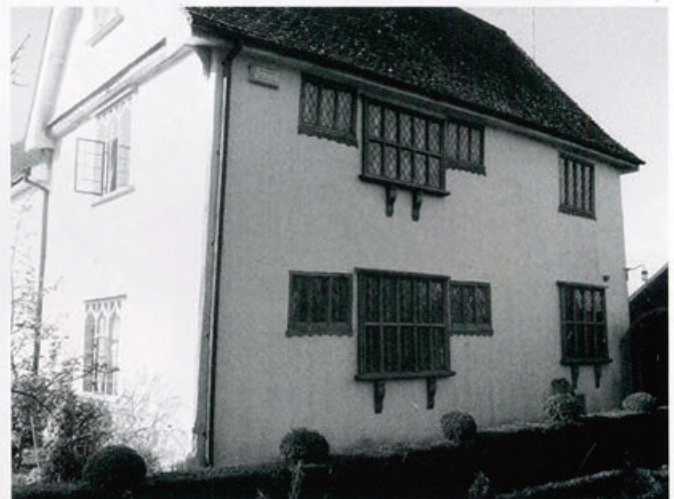
Fig. 11: Bedfield Hall, South side

The first of the 17<sup>th</sup> century improvements to the Hall in 1605 were practical and clearly associated with a more efficient chimney. The second rebuilding of the south wall in 1629 was more aesthetic and there is evidence for the provision of clerestories either side of the central window, which echo those still in place at the front of the adjoining parlour block. By 1629/30 the South front elevation was complete with its fenestration and probably stayed that way until about 1830, when the ogee-shaped windows gave a new uniformity to the whole (Fig. 11). The elevation on the North has several of the original 17<sup>th</sup> century windows and to the East a complete set, including oriels with clerestories and another flat window (Fig. 12). It is this side which gives some idea how the front looked before the early 19<sup>th</sup> century facelift.
